NATIONAL TRANSPORTATION SAFETY BOARD

HIGHWAY ACCIDENT REPORT

SURTIGAS, S. A.,
TANK-SEMITRAILER OVERTURN,
EXPLOSION, AND FIRE

NEAR EAGLE PASS, TEXAS
APRIL 29, 1975

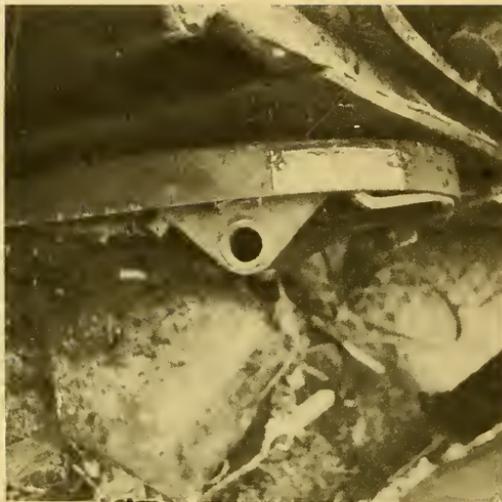
The fifth wheel was found attached to the trailer king pin. The vertical flange of the fifth-wheel plate, adjacent to the fifth-wheel cross-shaft, was bent outward. (See Figure 2.) The slide plate was found 50 feet south of the tractor. The transverse tube through which the fifth-wheel cross-shaft normally is positioned was bent upward and was disconnected from its right-side attachment. The metal failed in the weld. The fore-and-aft positioning plunger was flush with the bottom of the slide plate. (See Figure 3.)

Figure 2. Fountaine fifth wheel still attached to front section of tank after the accident.

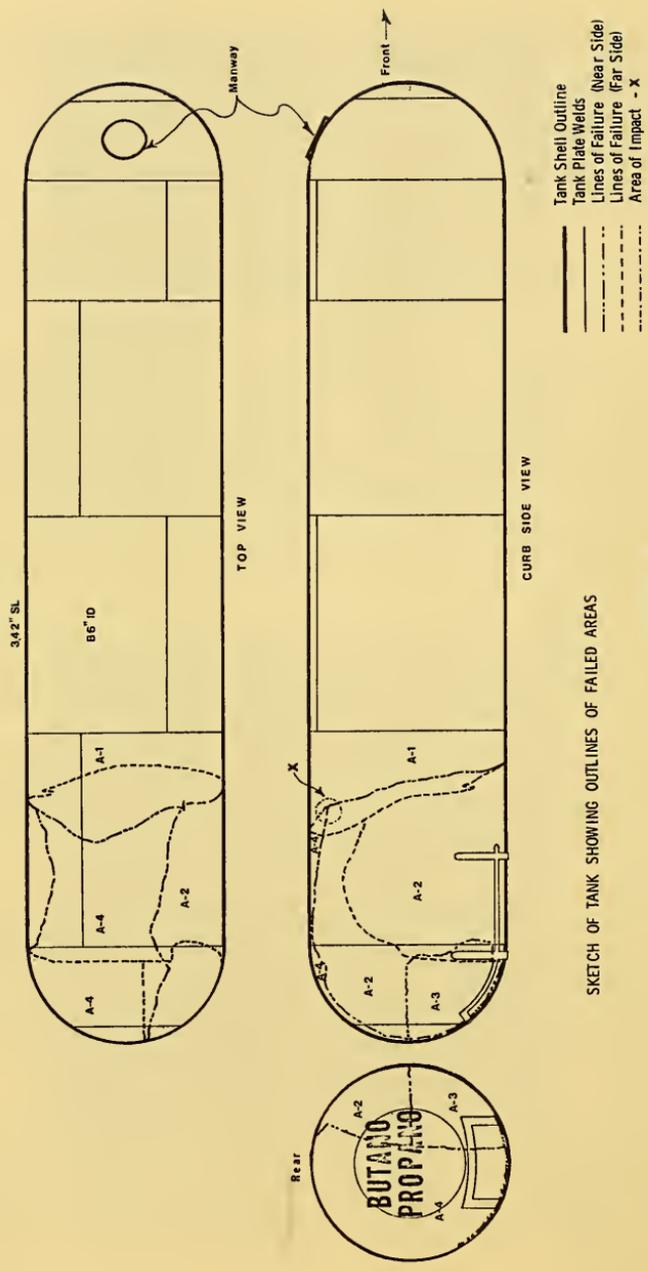
Figure 4.

The open end of the forward section of the tank was deformed into an ellipse. (See Figure 4.) The edges of the failure area had a mechanically deformed, gouged, and stretched dent. The dent was located on the right side of the tank, 26 inches from the top longitudinal centerline and 22 feet 9 inches rearward of the front head-to-shell weld. At the point of impact, the shell material was gouged from an original thickness of 0.387 inches to 0.279 inches. The internal tank pressure of 87 psig combined with the impact load to cause a shear-type failure around the tank circumference. The pressure, acting upon the tank material at the point of initiation of the crack, produced the extensive spread of the initial crack and permitted the violent rupture and separation of major parts of the tank.

The Safety Board analyzed a sample of the metal from the suspected impact area, and found no evidence of a preexisting crack. The analysis showed that the fracture appeared to be caused by an overload separation.

SKETCH OF TANK SHOWING OUTLINES OF FAILED AREAS

At impact, the tank shell was gouged severely and was forced into an elliptical shape. Impact forces also caused the tank to rotate counterclockwise about 40 to 50 degrees and to rebound to the south edge of the eastbound lane. The tank shell began to crack where it struck the headwall. The internal tank pressure of 87 psig combined with the impact load to cause a shear-type failure around the circumference of the tank.

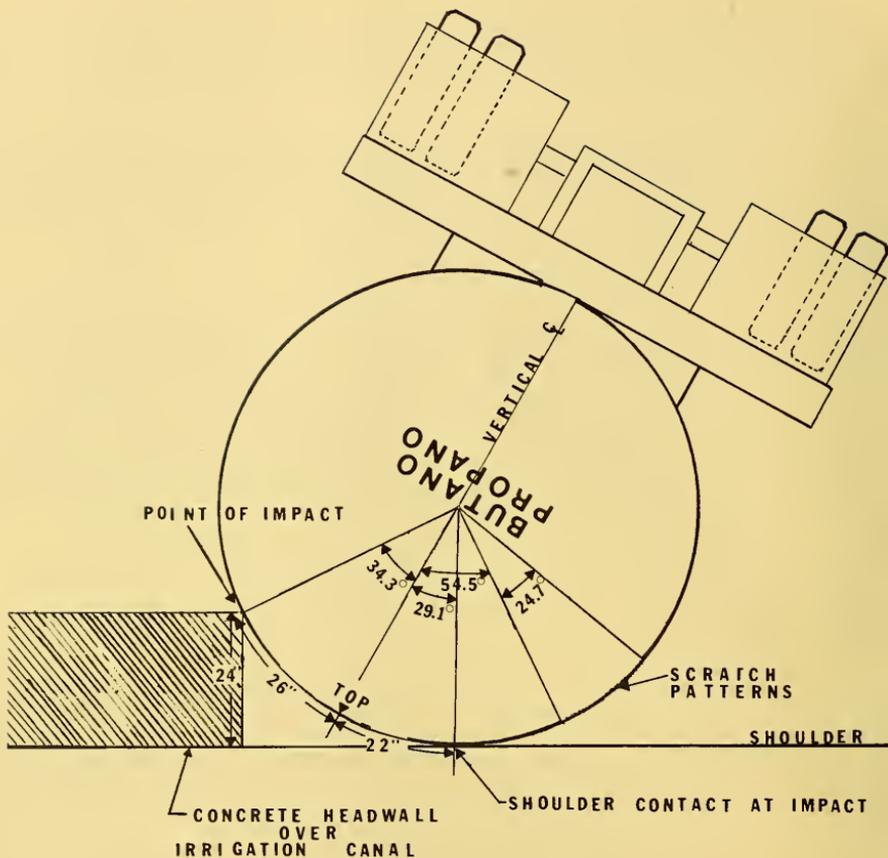
When the trailer separated from the tractor, the upsetting forces on the tractor were removed. The tractor dropped onto its right wheels, continued westward, and stopped opposite the headwall of the irrigation canal. The trailer rolled onto its left side and slid toward the concrete headwall and struck it. (See Figure 5.)

If highway design and construction standards and AASHTO recommended practices had been followed in the construction or remodeling of the concrete headwall, it would have been flush with the ground and the tank would not have ruptured. If remodeling of the headwall was not possible, it should have been protected by a barrier. Even though the truck might have penetrated the barrier, the barrier might have at least absorbed

FIGURE 5. CALCULATED ATTITUDE OF TANK-SEMITRAILER AT IMPACT WITH CONCRETE HEADWALL

enough energy or redirected the tank to prevent the rupture of the tank shell. The FHWA and AASHTO should encourage the States to consider such hazards in the development of their spot improvement programs.

"Promulgate a regulation to require the criteria established in the Handbook of Highway Design for Operating Practices (E2 Culverts and Bridge Structures) be mandatory for all modified and new designs.

"Compile and evaluate accident data related to unprotected, raised concrete headwalls and sidewalls which, because of their location, are roadside fixed objects, to determine whether added emphasis for their modification or protection is warranted."
